PERMIT SET

title
Details & Notes

A311

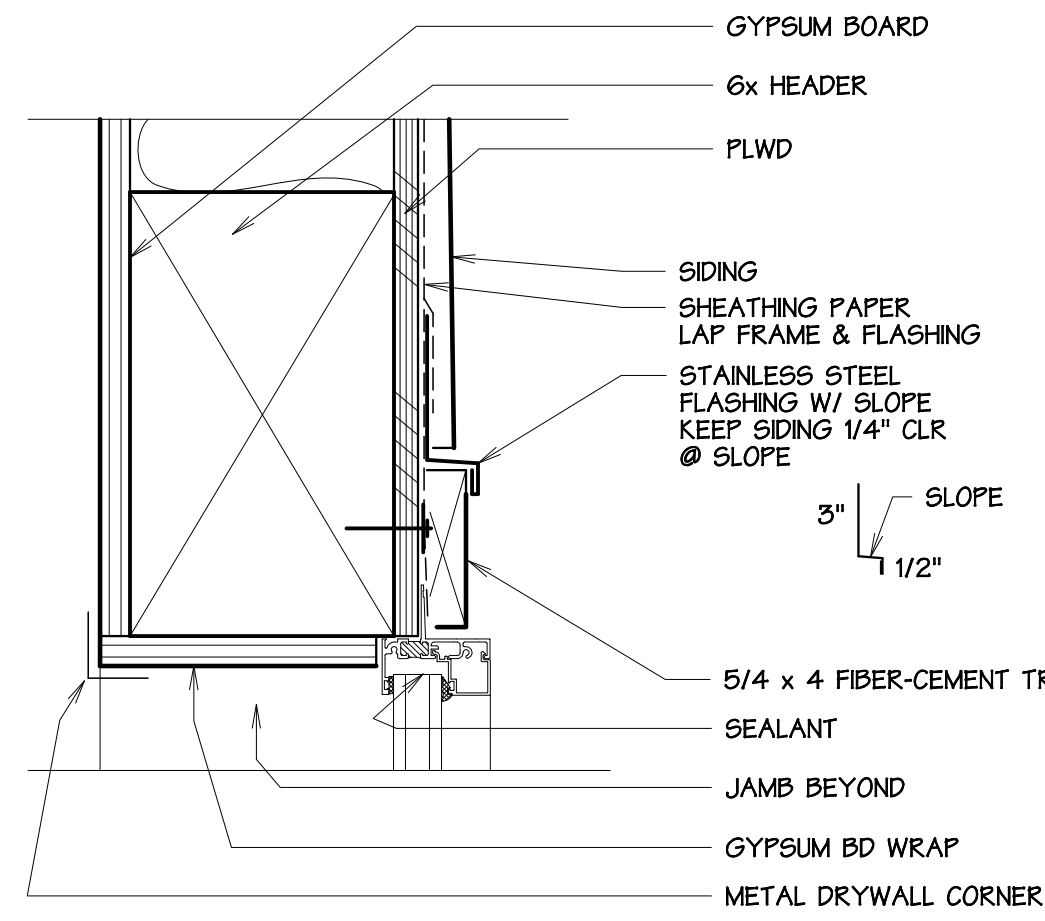
① WINDOW HEADER DETAIL
3" = 1' - 0"

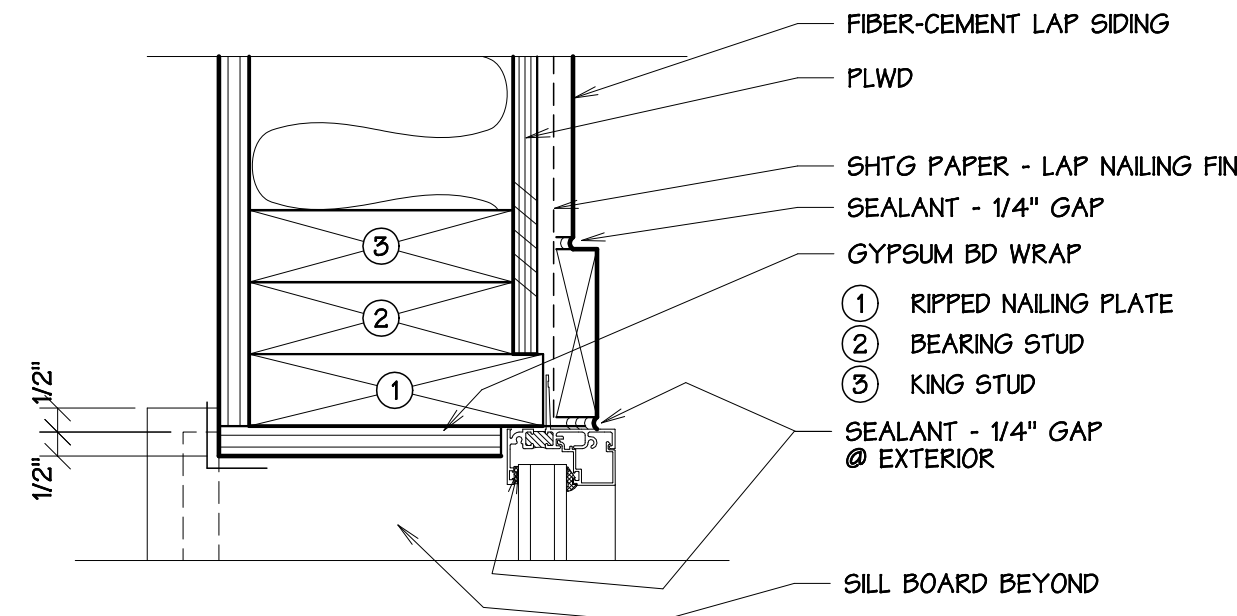
② WINDOW JAMB DETAIL
3" = 1' - 0"

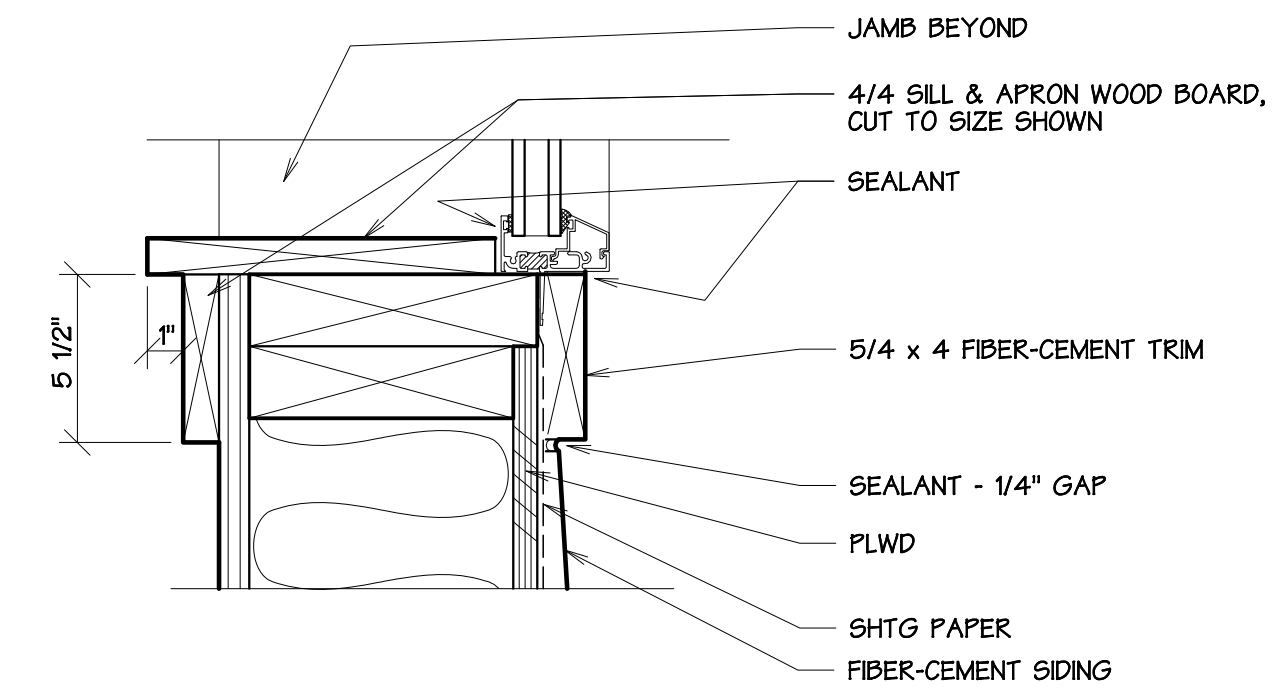
③ WINDOW SILL DETAIL
3" = 1' - 0"

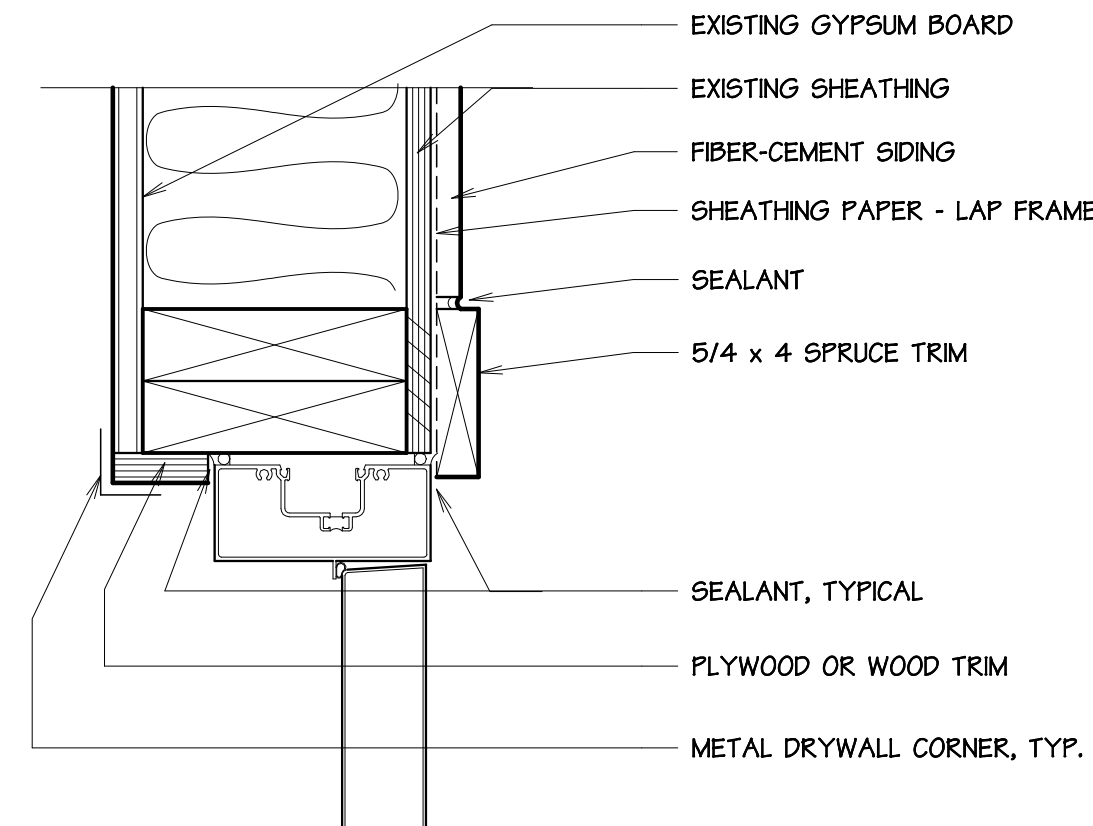
⑤ JAMB DETAIL
3" = 1' - 0"
